**Wire Rope Inspection Checks**

**Instruction No.:** SP85\_CI05

**Product:** SP85

**Operation:** Perform the wire rope safety checks

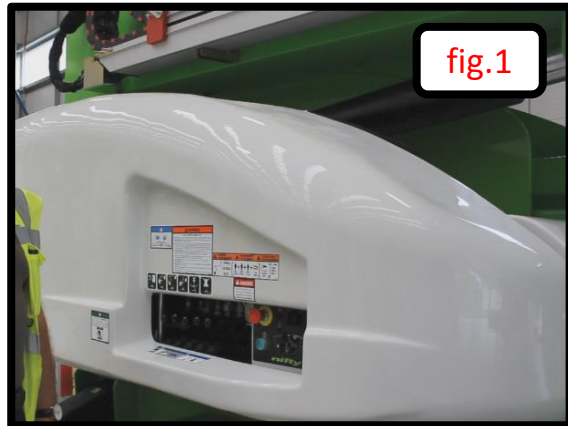
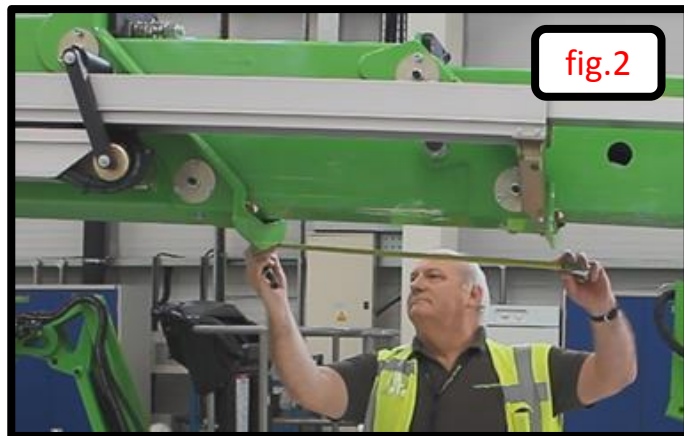
### 1. Extend the tele booms out.

Using the base controls (fig.1) extend the tele boom out, approximately 1m (fig.2), to expose the rope access windows locate on each side of the middle tele section (fig.3).

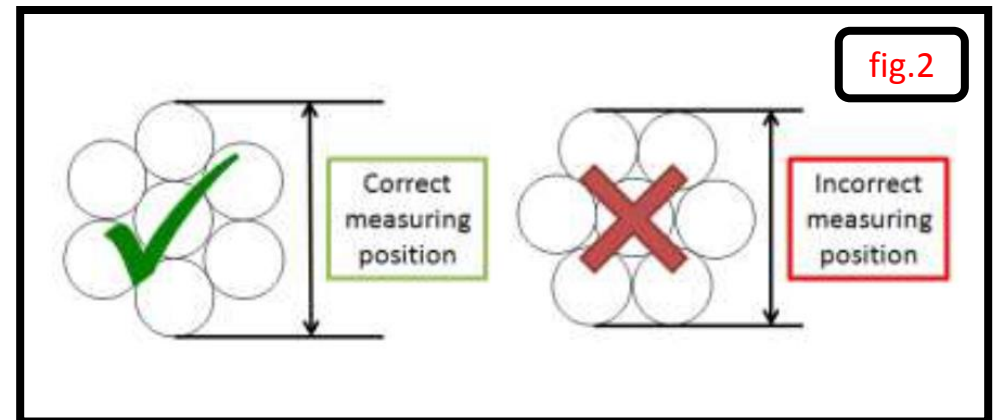
2. Measure the diameter of the wire ropes.

Using the Vernier's measure both of the rope diameters across two opposite strand bundles (fig.1 & fig.2).

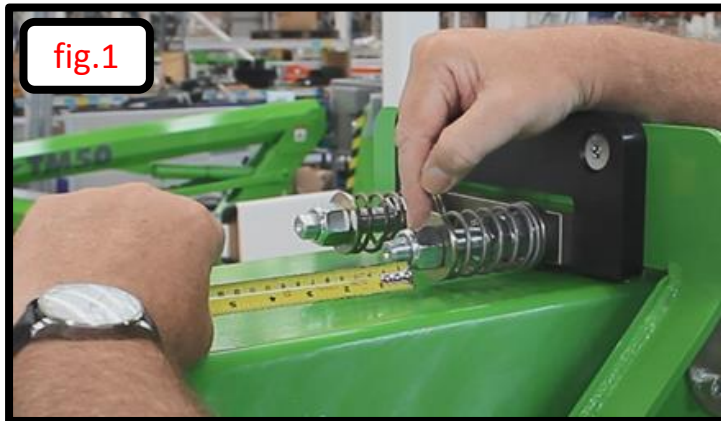
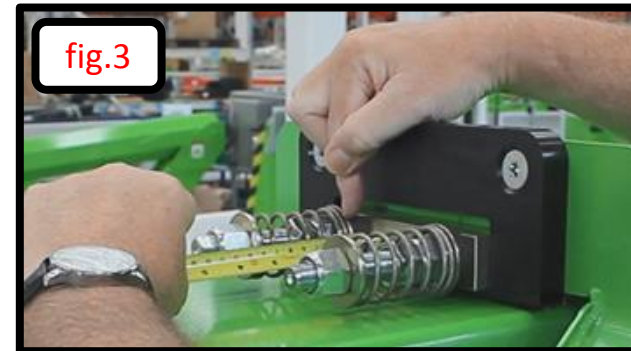
### 3. Check the outer rope anchor ends.

Using the tape measure check that; 6 threads,  $\approx 10\text{mm}$ , are showing through the locknuts (fig.1), both adjusters are approximately equal (fig.2) and both sets of Belleville washers are fully compressed ( $\approx 7.5\text{-}8\text{mm}$  total stack length) (fig.3 & fig.4).

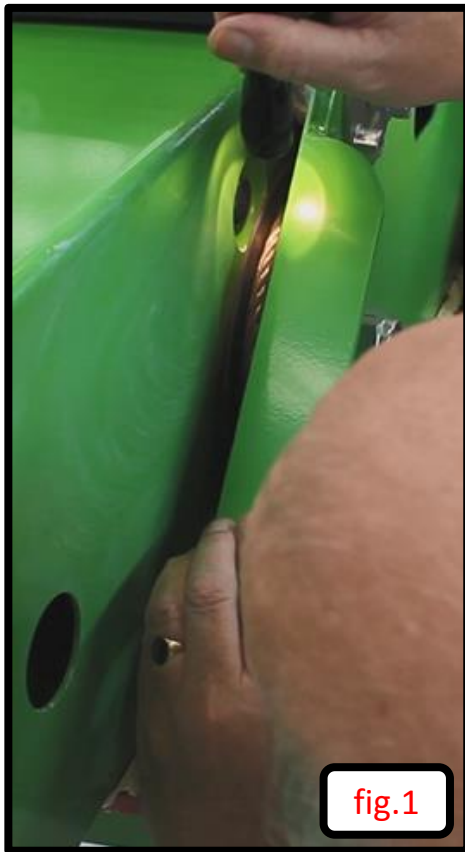
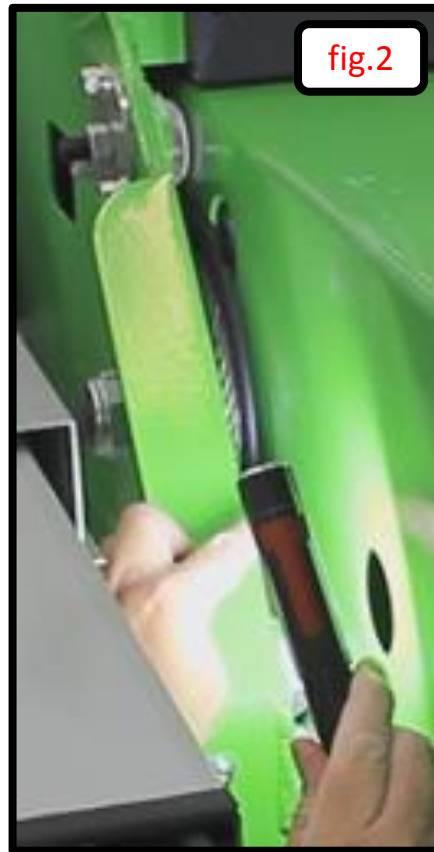
4. Check the clearance of the pulleys.

Using the torch ensure that both pulleys have sufficient clearance either side of them (fig.1 & fig.2) and that neither tele section has signs of fouling damage (fig.3).

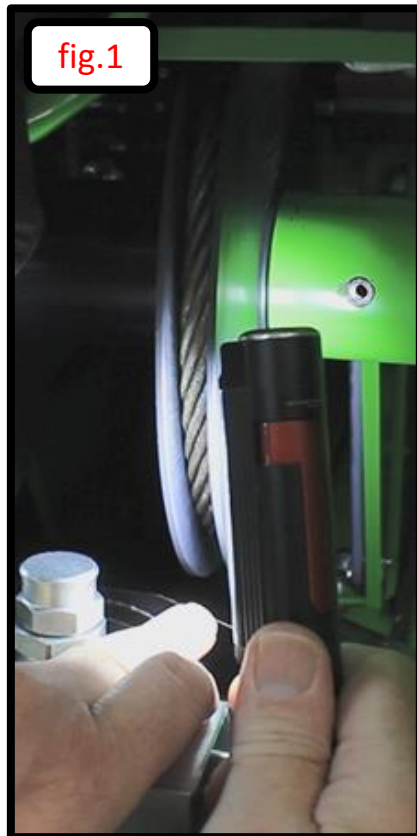
## 7. Check the clearance of the front pulleys.

Using the torch ensure that both pulleys have sufficient clearance either side of them (fig.1) and that neither tele section has signs of fouling damage. Again ensure both ropes run straight and parallel with the tele section (fig.2).

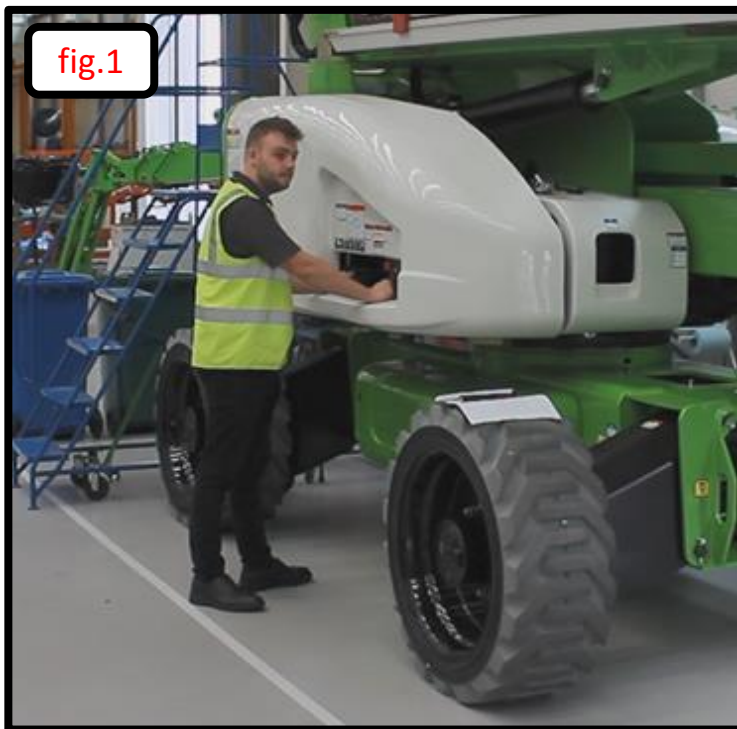
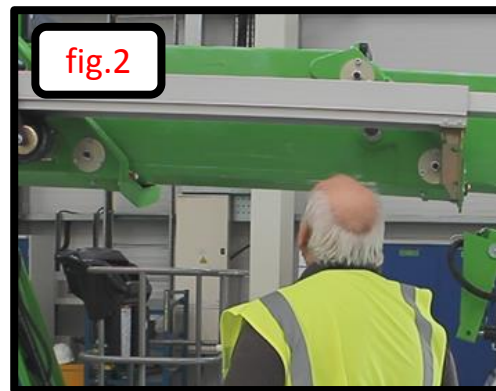
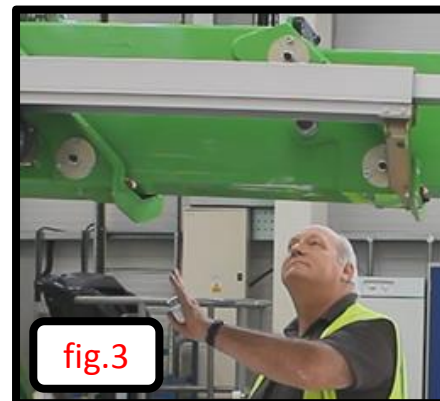
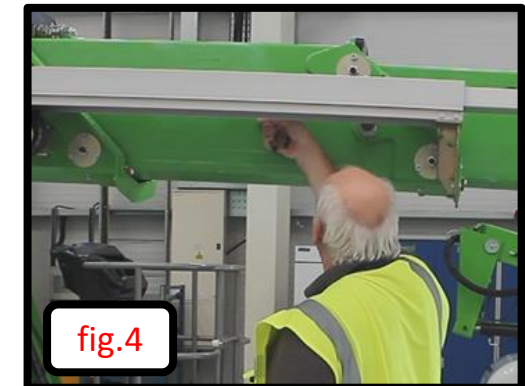
### 8. Check the wire ropes for broken strands (2 persons required).

While one operator slowly extends the tele booms out (fig.1) the other, using the rope inspection windows, checks the entirety of the ropes for loose strands (fig.2 & fig.3), if found a strand should not be cut, instead using pliers move the strand side to side until it comes away (fig.4).

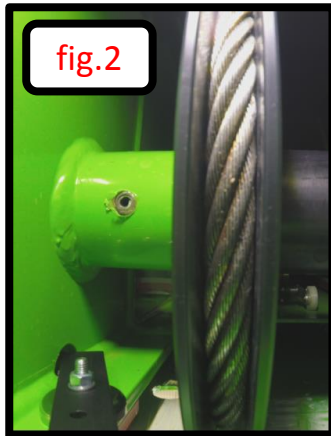
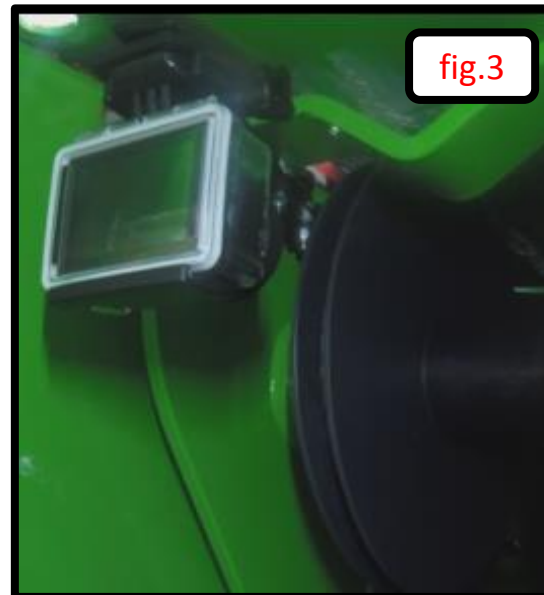
9. Fit the remote camera to the tele boom section.

Extend the tele boom out by  $\approx 300\text{mm}$  to gain access the top of the middle tele boom section (fig.1). Using P32552 with the camera mounted, position the action camera within the boom in line with one of the pulleys (fig.2 & fig.3), additionally position the magnetic torch to increase visibility (fig.4).

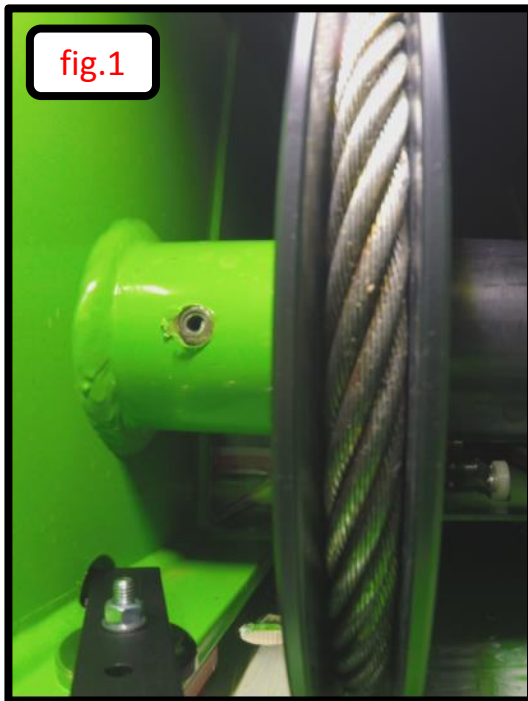
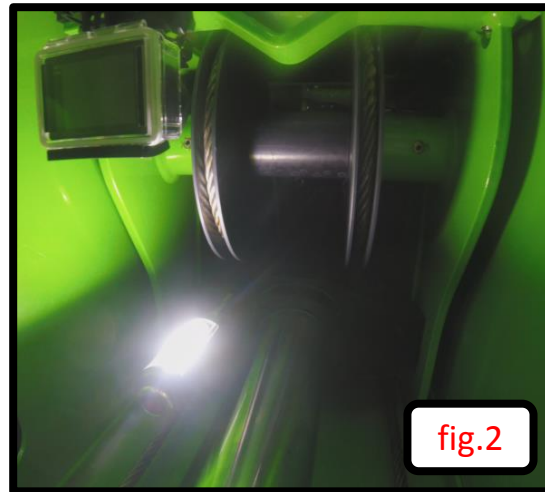
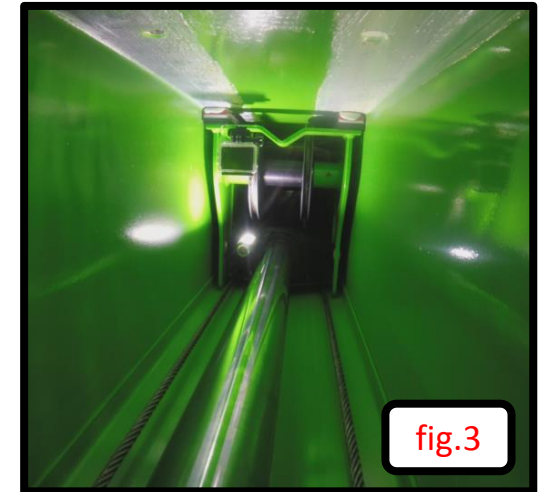
10. Record the tele boom being extend.

Record the wire rope whilst the tele boom is extend fully out (fig.1 & fig.2 & fig.3). Once recorded review the footage and note all damage. Bring the tele boom back in to the '300mm out' position, as to not damage your equipment, then repeat this process on the second pulley and rope.
